Magellan Midstream Partners, L.P.		07-FORM-1581	
PIPELINE MAINTENANCE REPORT		Revision: 4	
Asset Integrity	01/23/07	Page 1 of 5

See Page 3 for Form Information and Instructions. Line Strike 12"

<input checked="" type="checkbox"/> MAINLINE <input type="checkbox"/> FACILITY	Purpose of Report (See page 3 for examples) LINE STRIKE INVESTIGATION	Pipeline Name / Facility Name & Number FALLS CITY TO IRVINGTON #5-12"	Line I.D. Number 6225
Trench Number	Mile Post 111.7	Latitude - Longitude (WGS 84 and Degrees - Decimal Minutes) Lat. = N40.312968	County NEMAH
Legal Description	Reference Drawings (Alignment Sheet OR Facility Drawing No.)

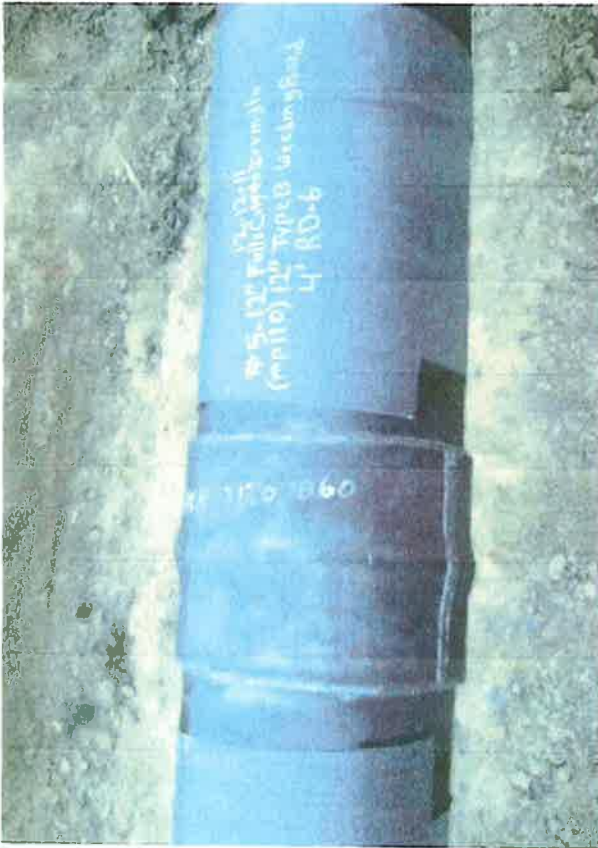
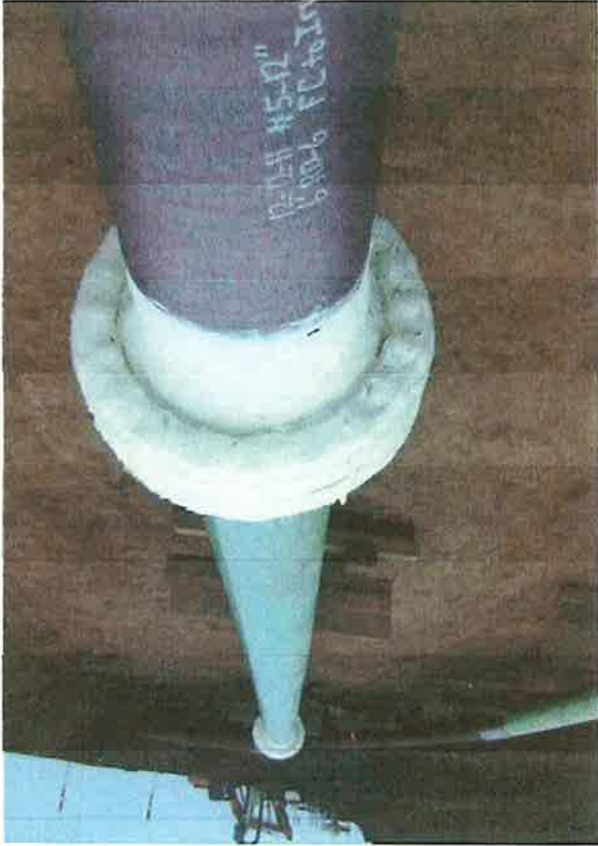
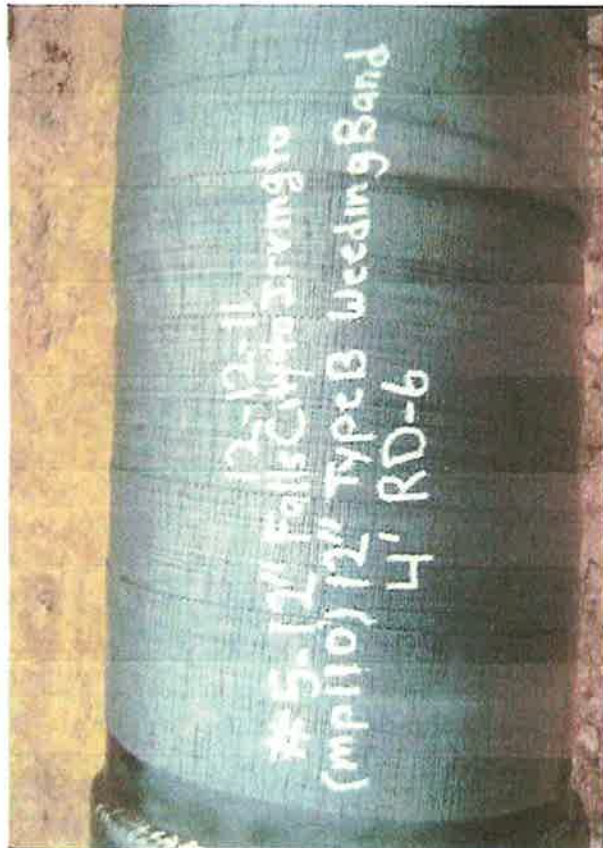
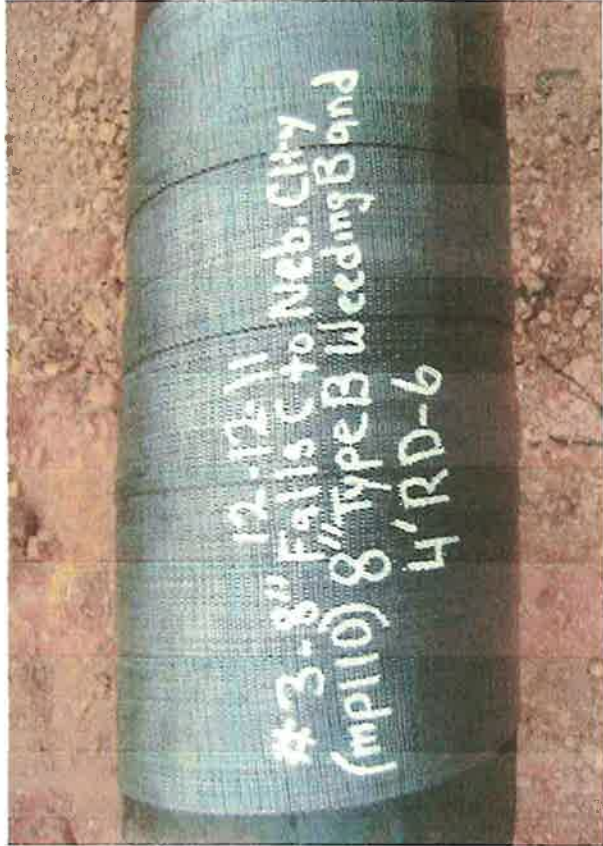
14-12-11 8.5-12"
6 RD-6 FC to Irvington

SPR-UT 655868 A
PIONEER 12 3/4 X 312 H 11.400 AFT
PSL2/APSL/X52/X80 ERW CWT
P0-17001518 4/11/11
14-16 MILES VALSPAR 2000
